BODY BEAUTIFUL

the rebuilding of a TVI
by TREVOR DAVIES

CHAPTER 1 - SETTING THE SCENE

CHAPTER 2 - BODY BEAUTIFUL

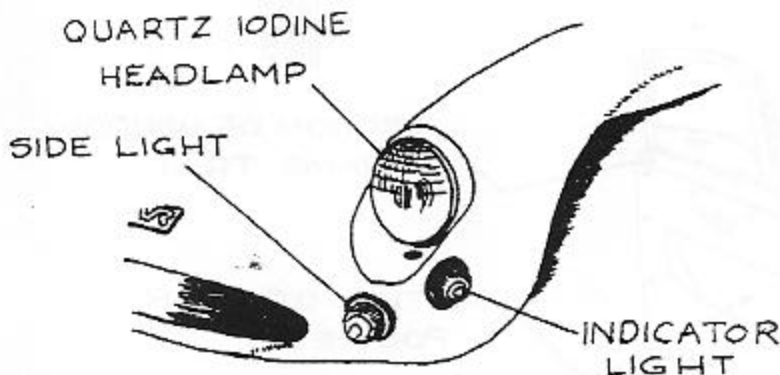
FIG.1. NEW LIGHTING LAYOUT

The car as bought was bumperless so the holes for the retaining bolts were filled in and rubbed down flush. The position of the indicators and the size of the side lamps are not ideal in the interests of safety, so a new layout was devised as shown in Fig. 1.

Two new side lamps matching the indicators (Lucas L594) were positioned forward and directly beneath the headlamp recesses, and the indicators were then positioned slightly higher and on the corner of the bonnet. The side lights are now larger and more obvious, also the indicator can be seen from the front and the side of the car. Modifications were made in the off-side wheel arch by cutting away material and replacing it with a sizeable cowl made in sheet metal to match a similar cowl fitted in the wheel arch of the body. The cowl is to provide clearance for the ram pipes of the Weber carburetors and protect them from road dirt and water thrown inside the wheel arch.

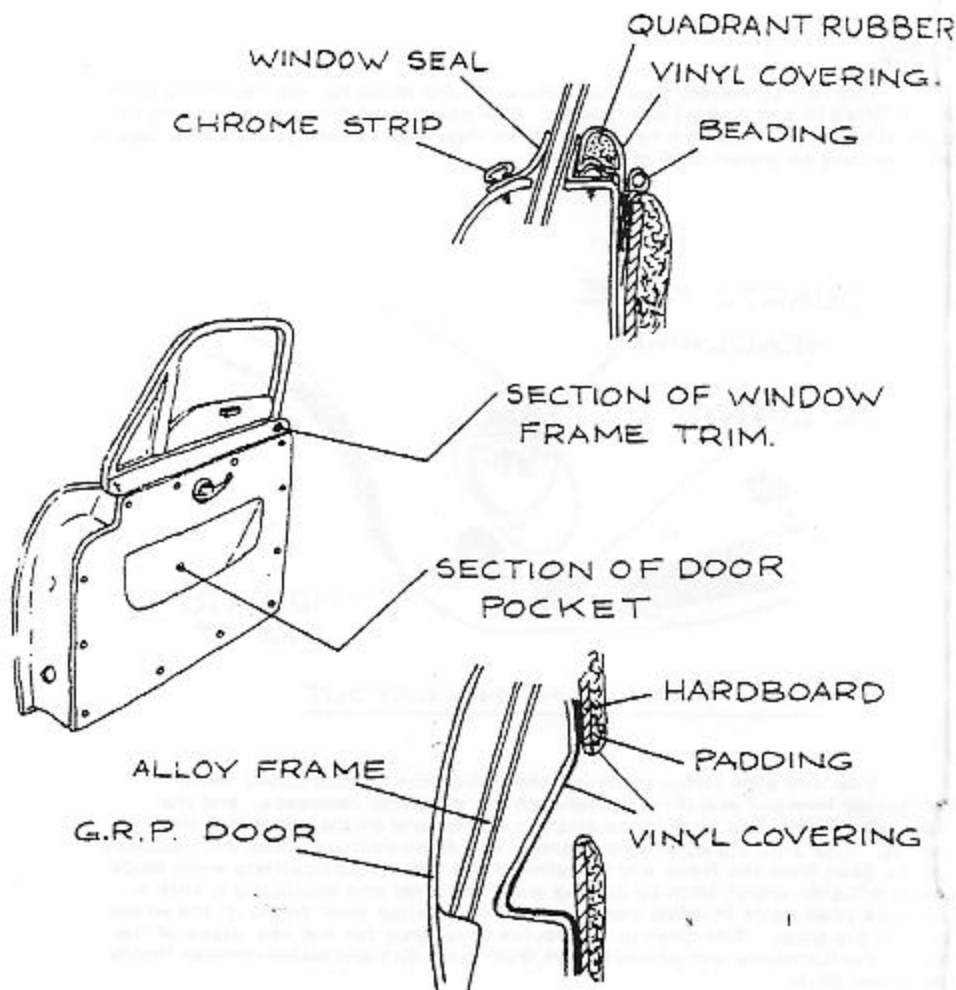
FIG. 2. DOOR TRIM.

The doors are lightweight with perspex windows and aluminium frames (no window winding mechanism) and only a new trim panel was needed to replace the old rotting trim. It was made up as Fig. 2 shows with the panel forming one side of a rigid open pocket.

To tidy the upper edge of the door and cover the window frame screws I made a padded roll with the trim material (black vinyl) and a strip of quadrant door seal rubber (see Fig. 2). The glued edges of the vinyl are extended down behind the trim panel for disguise and neatness.

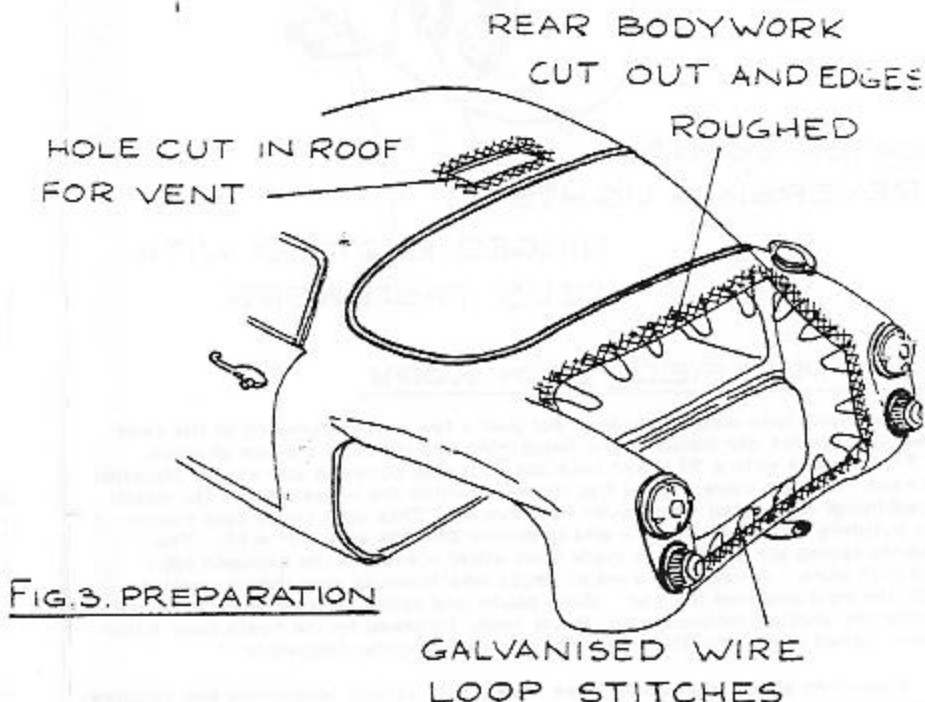
FIG.3. PREPARATION

1. The cockpit was poorly ventilated and tended to heat up like a greenhouse in summer.
2. The position of the intake on the heater fan was near perfect for drawing in the carbon monoxide of the vehicle in front.
3. A real TVR screamer! - the spare wheel had to be dragged over a seat and through the narrow door together with any luggage that might be tightly packed into the very tiny space available, each time it was required.
4. Footwells half full of water were a regular feature in wet weather.

Taking the problems in the order above, the roof ventilator was manufactured and fitted as shown in Fig.3 and Fig.4.

Suitably protected as described earlier, I now cut a very large hole in the rear of the body (see Fig. 3) and armed with cardboard, hundreds of news-papers and plenty of paste (Polycell) proceeded to make a support pattern on the glass fibre body. The pattern was made slightly smaller than the required level to allow about $3/16"$ - $1/4"$ thickness of glass fibre and body filler. When the pattern was dry and firm it was greased with several thick coats of furniture polish. The area surrounding the pattern (about 3" wide) was roughed with a rotary sander and then perforated with $\frac{1}{8}"$ diameter holes. Using soft galvanised steel wire large loops were formed over the pattern by stitching through the holes with the wire (Fig. 3). The glass fibre structure was now built, taking small areas at a time to keep the thickness even and dissipate the heat generated by catalyst action. The curved sharp edge had to be reinforced to ensure it would withstand the weight of any 14 stone CAR SCRUTINEER! and so was strengthened by bonding a strip of $1" \times 1"$ aluminium angle into the structure. Having applied a thick ($\frac{1}{8}"$) coat of resin body filler to the rough fibre, I now started the hard graft of smoothing out all the bumps to match the professionally moulded body of TVR's. Having manufactured a flat slab back, it was easy to carve out a boot lid using a keyhole saw. Hinges were made from two large steel gate hinges bolted to the upper edge of the body and cranked (see Fig. 5) to clear the rear number plate lamp. I fastened the lid in the bottom corners with 'IDZUS' spring fasteners which I had available amongst my bits and pieces from various Aircraft Companies!

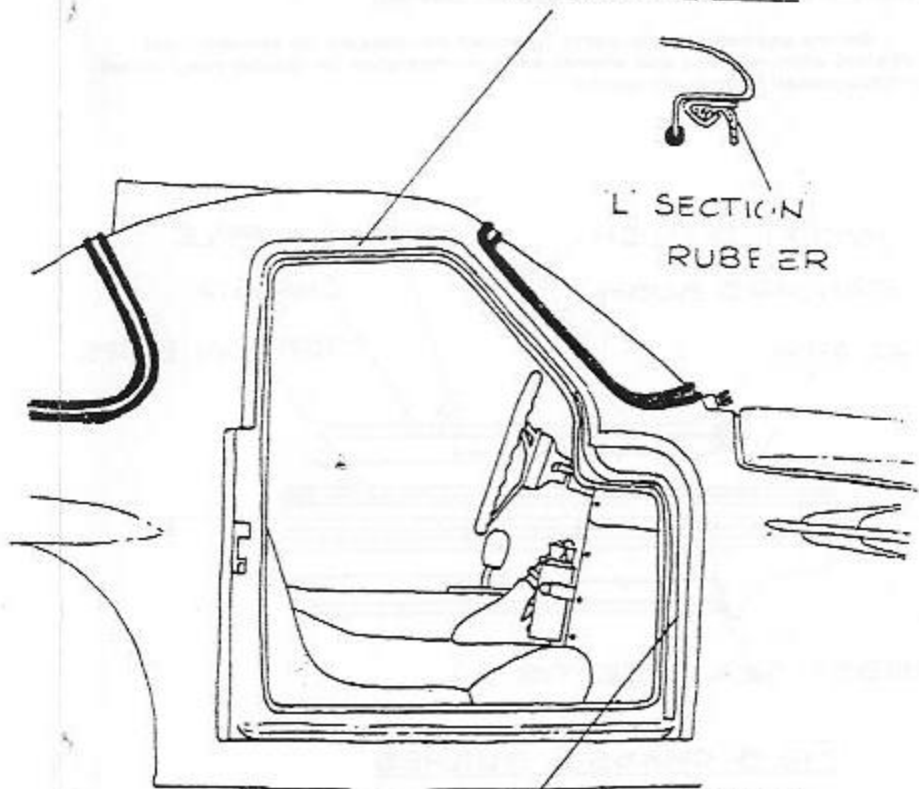
FIG. 7. DOOR SEALS

The leak into footwells on TVRs seems to come from the poor door sealing arrangement. The worst area is undoubtedly the forward edge of the door, which was easily cured by glueing quadrant section rubber strip into the moulded recess at the edge of the body. Also on the front edge is a strip of rubber seal fixed to the inner flange of the body, which is compressed against the door trim when the door is closed. The seal in the window frame area is very similar to the standard with the exception of having no drain channel and a more flexible seal section (see Fig. 7). The seal strip on the inner flange overlaps and fits inside the upper window frame seal by several inches.

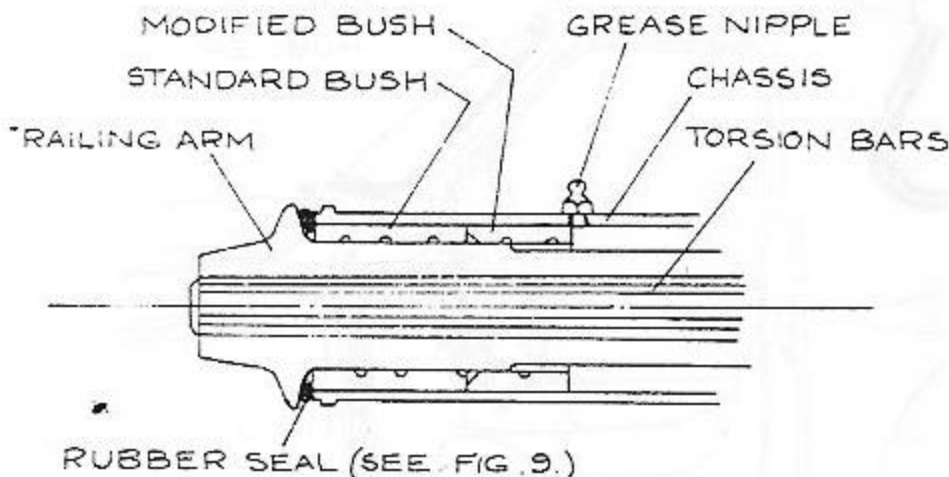
FIG. 8. CHASSIS BUSHES

The main features which required improvement were the infamous trailing arm bushes and rubber suspension bushes. The trailing arm bushes as bought are slightly shorter than the trailing arm bearing surface so I extended the length of bushing by fitting a shortened bush in addition to the standard bush. (see Fig. 8). The mating edges of the bushes were chamfered to ensure a clear path for grease. The second problem with the trailing arm bearings is to stop the water and dirt getting in and the grease running out. In the first instance I used a circular section rubber seal (see Fig. 8) trapped between the trailing arm flange and bush face. This worked fine but unfortunately I had chosen seals made of a rubber which was not compatible with mineral grease and so rotted away in approximately 5,000 miles. The replacement of these seals would mean completely stripping the suspension so I devised another seal arrangement which is inexpensive (about 4d per seal) and can be fitted in situ and lasts a reasonable time (about 5,000 miles).

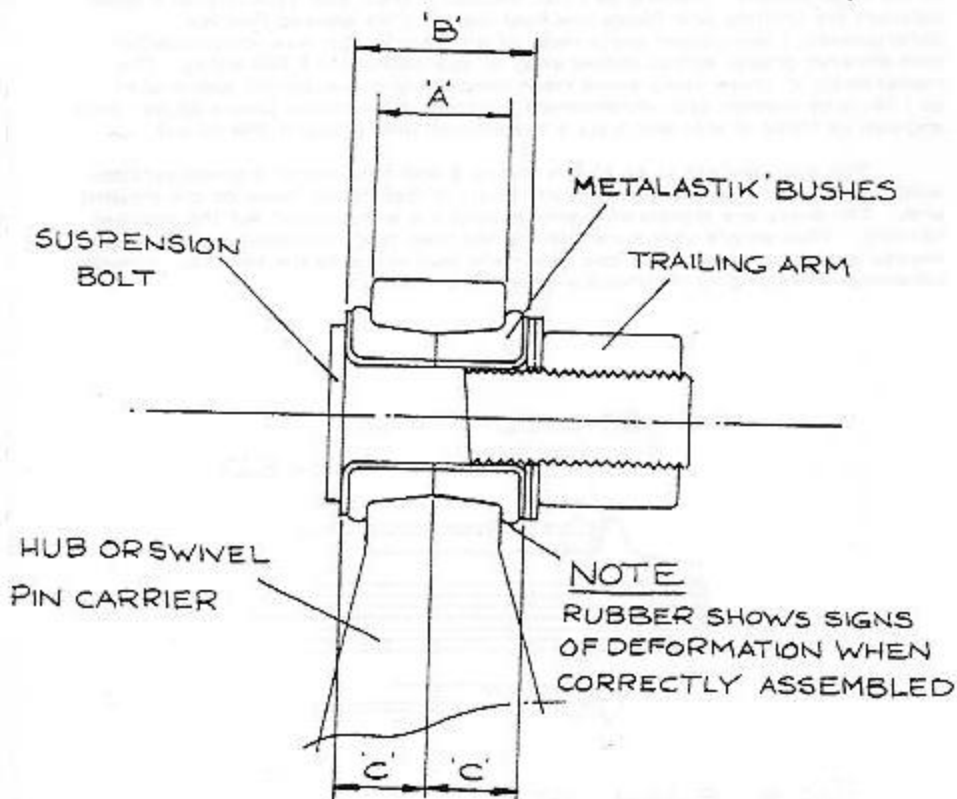
FIG. 10. SUSPENSION BUSHES.

The 'Metalastik' suspension bushes are too long as supplied, so they were cut down in length to suit the hole in the hub casting into which they were fitted. To get the maximum life out of these bushes I have found it is necessary to clear the hole of any sharp edges or protrusions and then tailor the bushes to suit a measured thickness of casting (see Fig. 10).

To the thickness 'A' 0.4" was added and then this total 'B' divided by two gives the length 'C' of each bush for that particular hole.
