Griffith Club of America

#### NEWS

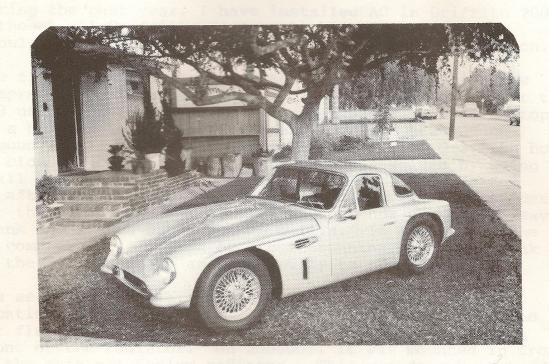
The feature car of this newsletter is 2005178 owned and restored by Steve Ferron of Redondo Beach, California. This car is one of the most innovatively and extensively modified in the club. In Steves words, "the car was bought off a farm in the San Fernando Valley where it had sat for six years... at the time of purchase, goats were using it as a hill to stand on".

Currently, the car has 42,000 miles and has been repainted in Diamond Silver. Modifications to the car are extensive and include power assisted rear brakes, Jaguar XJ 12 center section, roll bar, air conditioning, redesigned teak wood dash, complete leather interior and Borrani wheels.

The engine is a 289 HP with 10.5 pistons, Crane cam and kit, swirl finish valves, roller rocker arms, oil cooler, 10 quart pan, Cobra intake with 650 Holley and an Accell dual point distributor.

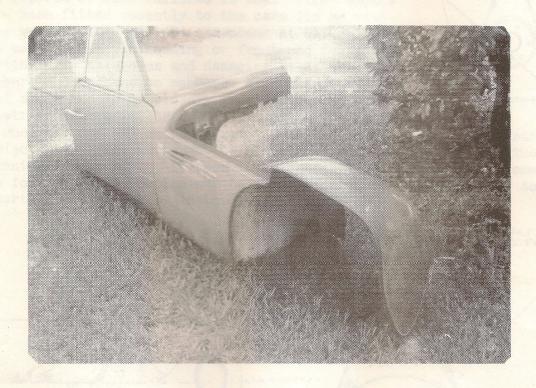
Example picture of right side cut. Pictures are available of all other parts through the club

Both sides are available from the front inner fender to themiddle of the top of the rear wheel arch. The door frames and metal bracing in this area are good and non-rusted.
