G R A N T U R A

Mk.1, 11 & 11a

WORKSHOP

TVR
CAR CLUB

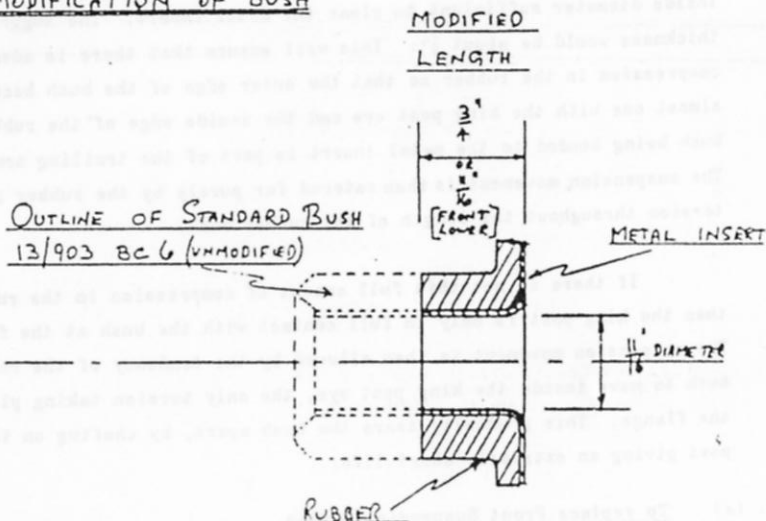
(a) MODIFICATION OF BUSH

The metalastic bushes used to mount the king posts onto the trailing arms are part number 13/903BC6 (as used in the Rover part number X4478). These are then cut down in length to $\frac{3}{4}$ " with the exception of the front lower ones which should be $\frac{11}{16}$ " long.

In theory these bushes are compressed in their length so their diameter expands so as to grip inside the eye of the king post. In order that this can occur the rubber must protrude beyond the metal insert as in the unmodified bush. When these bushes are shortened by turning in a lathe the rubber gives a little and provides this effect, to a small extent. However to ensure that there is sufficient rubber to compress to give the required increase in diameter before the metal inserts come together it is convenient to insert a washer of uncompressible material between the two bushes which has an inside diameter sufficient to clear the metal insert. The suggested thickness would be about $\frac{1}{8}$ ". This will ensure that there is adequate compression in the rubber so that the outer edge of the bush becomes almost one with the king post eye and the inside edge of the rubber bush being bonded to the metal insert is part of the trailing arm. The suspension movement is then catered for purely by the rubber in torsion throughout the length of the rubber bush.

If there is not this full amount of compression in the rubber then the king post is only in full contact with the bush at the flanges. The suspension movement is then allowed by the tendency of the rubber bush to move inside the king post eye, the only torsion taking place at the flange. This gradually tears the bush apart, by chafing on the king post giving an extremely short life.

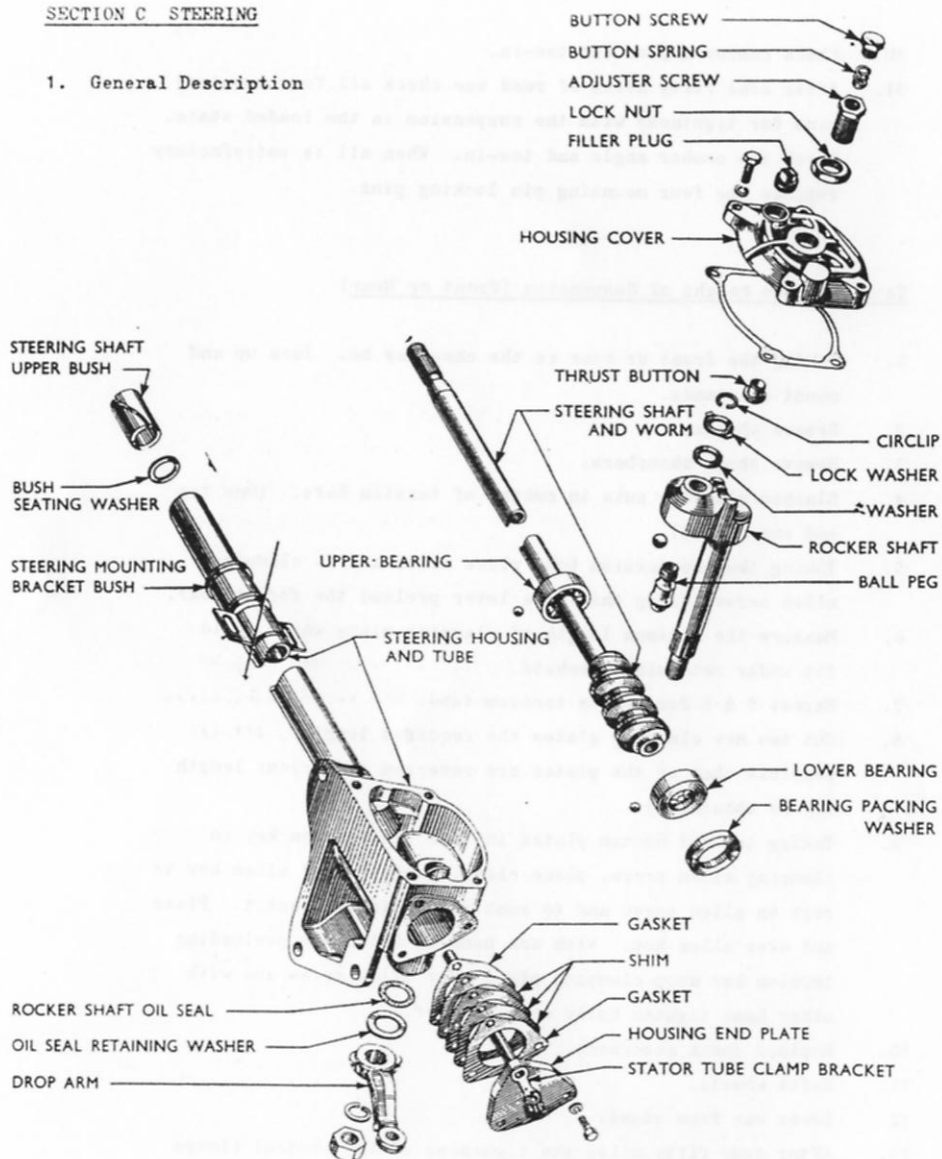
The steering box is of worm and ball peg design made by Burman Gear for the Ford 101E Anglia (ie the left hand drive version of the 100E Anglia). The worm is an integral part of the steering shaft and is carried on ball bearings at each end. The ball peg which engages in the worm fits into the upper end of the rocker shaft and is secured by a locking washer and circlip. Ball bearings in the top of the rocker shaft permit the ball peg to rotate. The column is shortened

and the unit is mounted upside down with a grease nipple in the place of the oil filler plug. On left hand drive TVRs the 100E version was used in a similar manner. The drop arm is a TVR flame cut piece of steel, machined to fit the splined steering box output shaft and to take the taper of the track rod ends. The track rods (a short one to the offside wheel and a long one to the nearside wheel) are made up using conventional parts having left and right hand threads for track adjustment. The steering shaft is located in the outer case at the top by a felt bush.

Provision is made for wear in the steering box to be taken up by removing shims to reduce steering shaft end float and an adjuster screw to eliminate rocker shaft end float. The ball peg may be replaced if necessary.

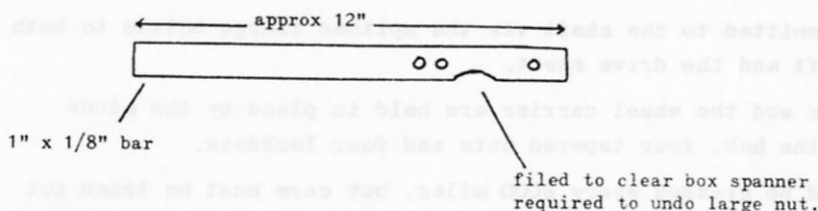
A special tool to assist with removing companion flanges may be useful:-

The tool is bolted to the companion flange whilst undoing the large nut. Alternative holes are for front flange (close spacing) and side flanges (large spacing).

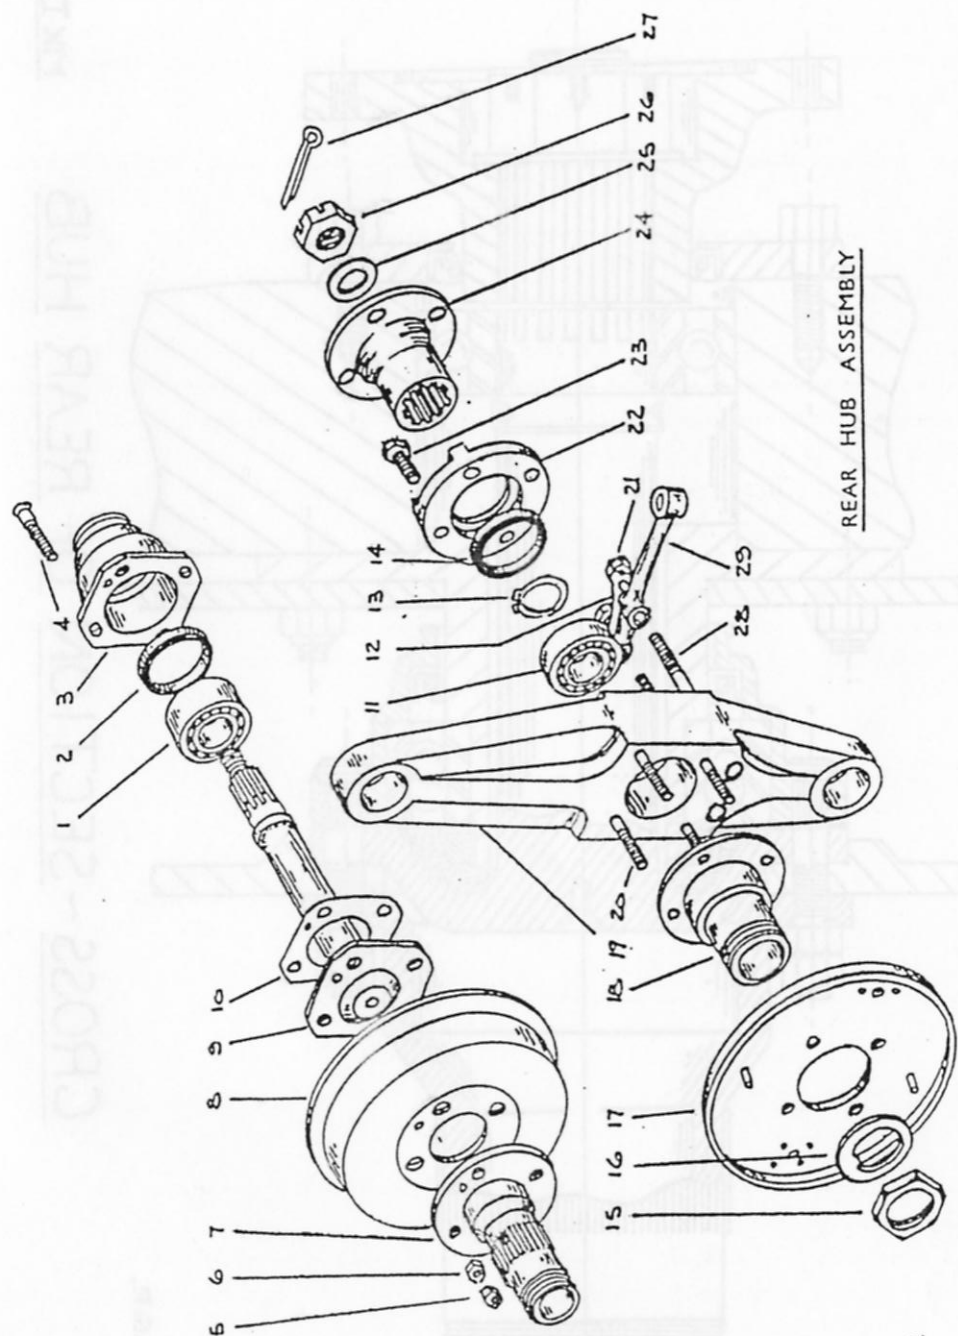
REAR HUB ASSEMBLY

| 14. Oil seal (flange) | 29. Tie bar supporting bracket |
| 15. Retaining nut | |

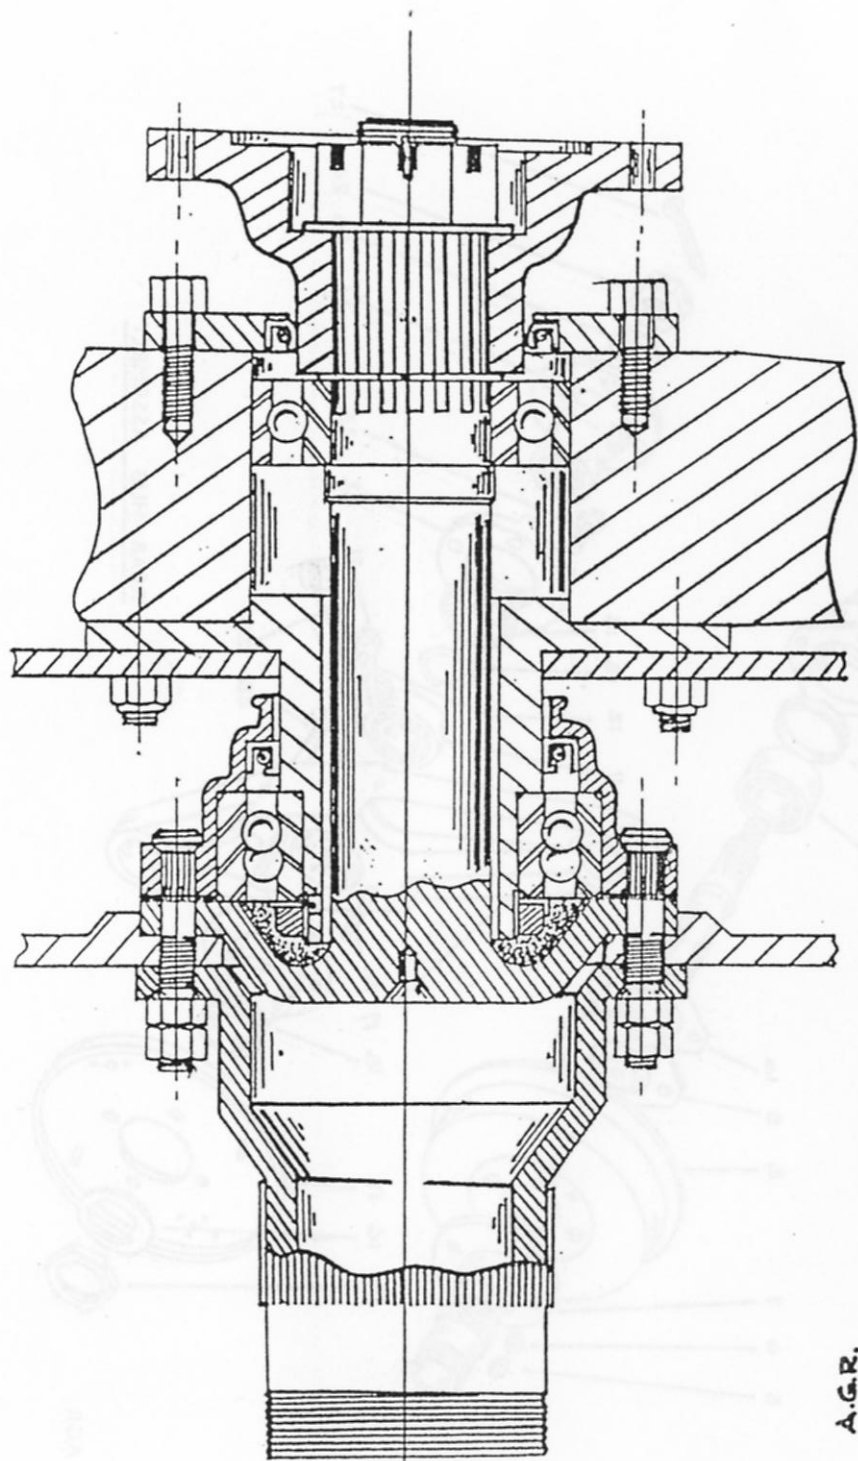
CROSS-SECTION OF REAR HUB

The wheel carrier is supported by small outer and larger inner, angular contact roller bearings, this arrangement allows a small amount of adjustment to be made for wear.

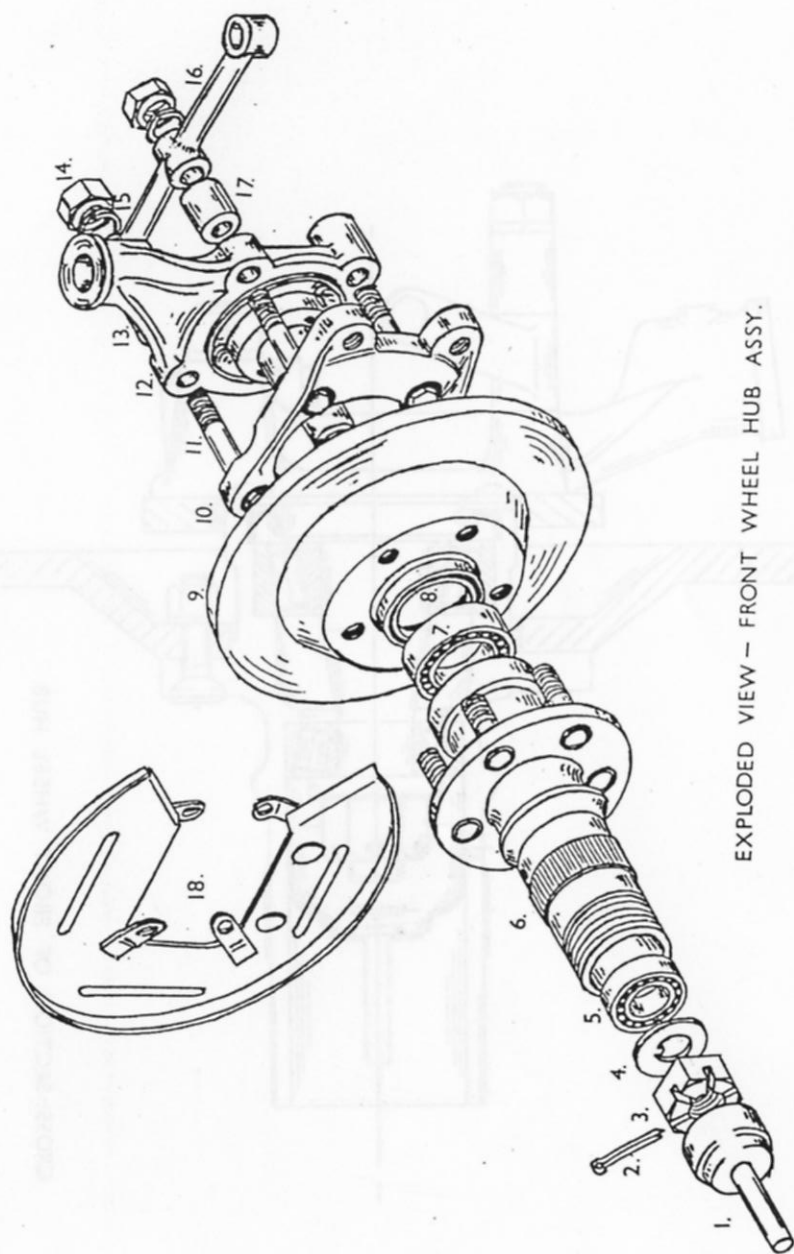
EXPLODED VIEW - FRONT WHEEL HUB ASSY.

| 8. Oil seal | 17. Spacer |
| 9. Brake disc | 18. Splash guard |

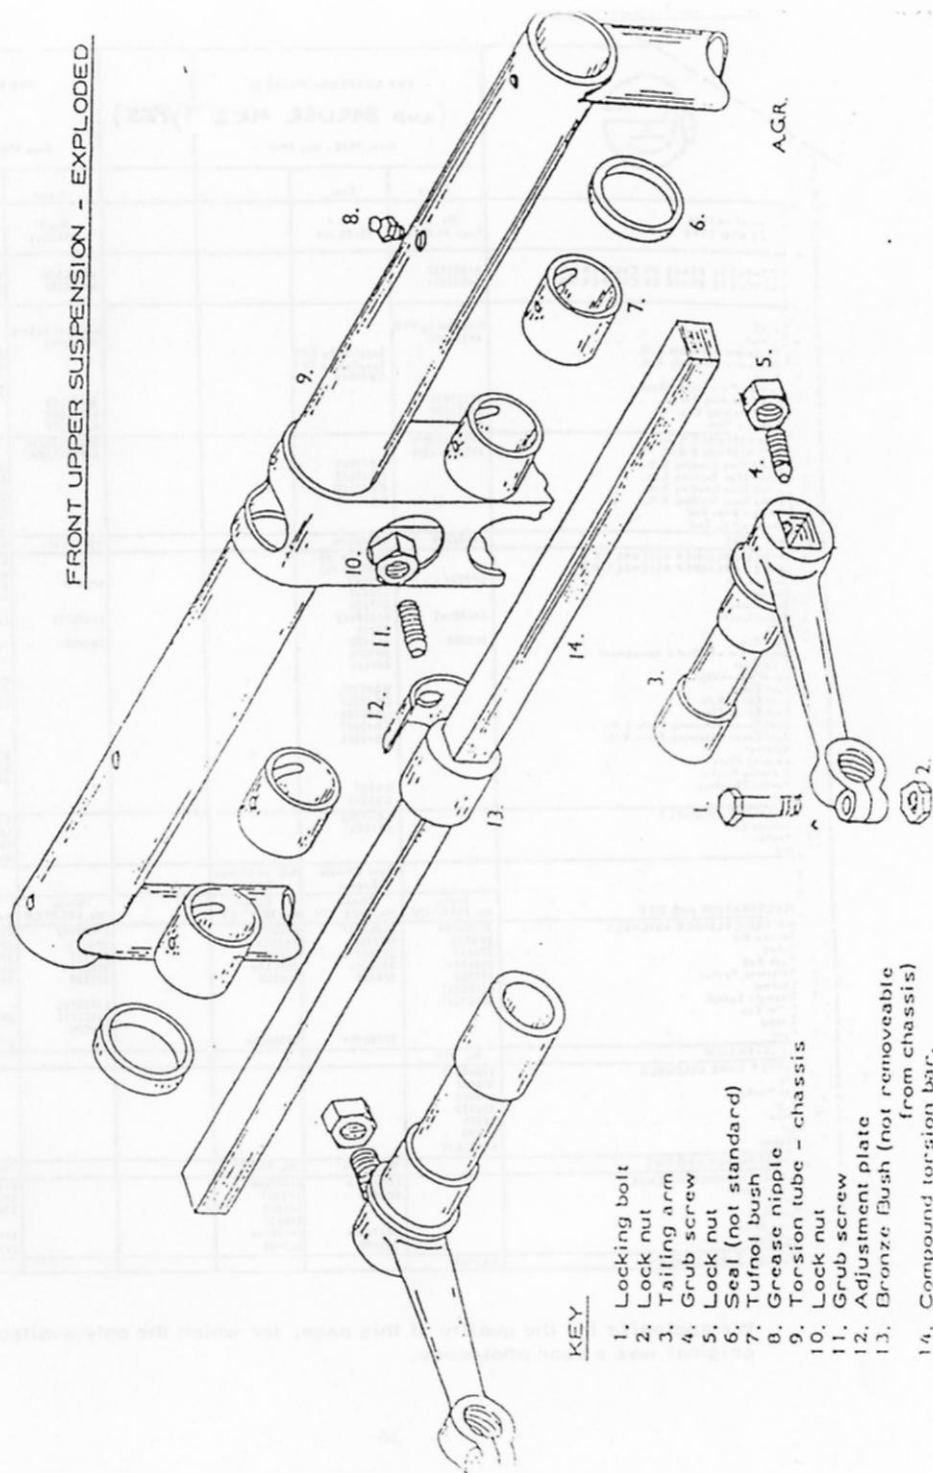
FRONT UPPER SUSPENSION - EXPLODED

1. Locking bolt
2. Lock nut
3. Tailing arm
4. Grub screw
5. Lock nut
6. Seal (not standard)
7. Tufnol bush
8. Grease nipple
9. Torsion tube - chassis
10. Lock nut
11. Grub screw
12. Adjustment plate
13. Bronze Bush (not removable from chassis)
14. Compound torsion bar.
