BODY BEAUTIFUL

the rebuilding of a TVI
by TREVOR DAVIES

CHAPTER 1 - SETTING THE SCENE

CHAPTER 2 - BODY BEAUTIFUL

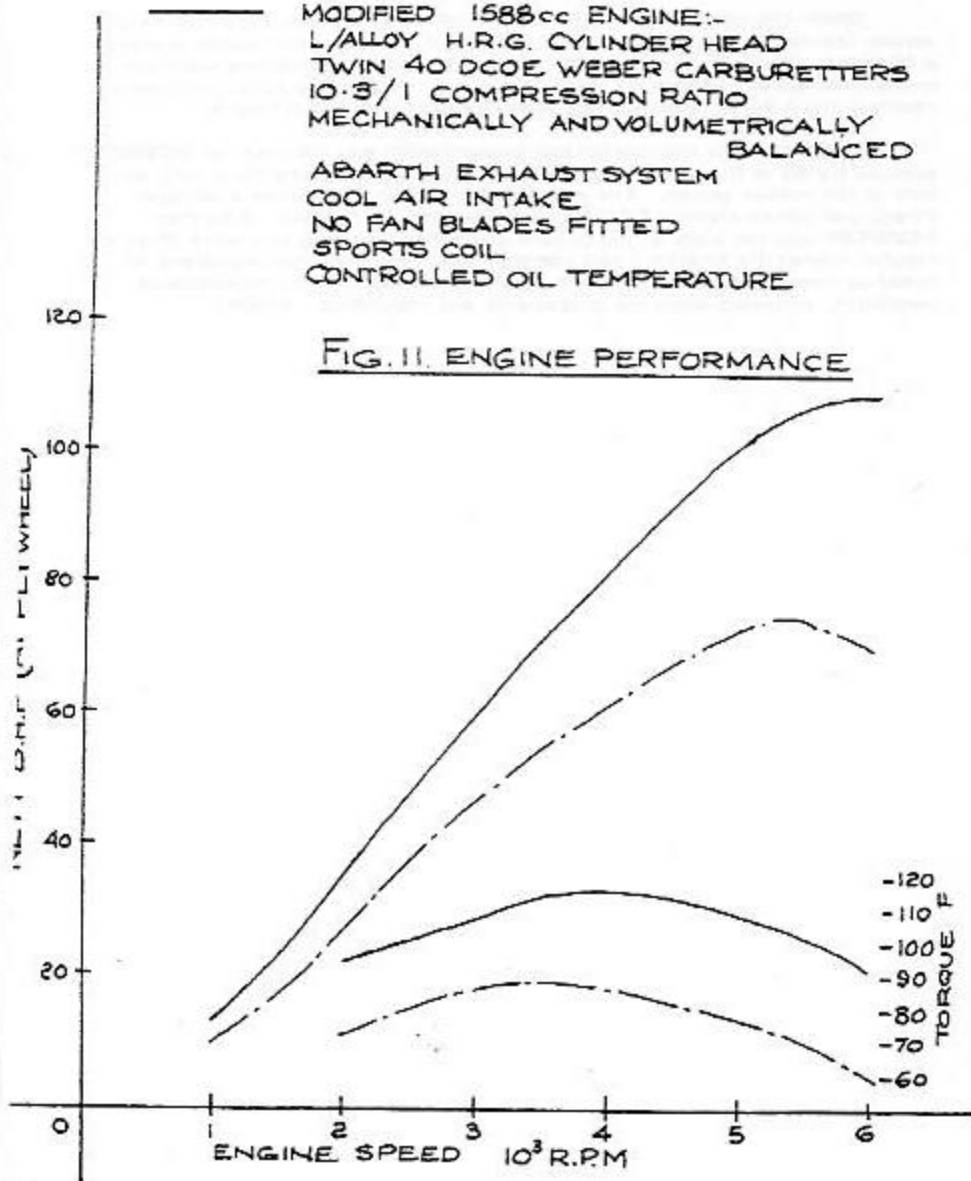
FIG. 11. ENGINE PERFORMANCE

— MODIFIED 1588cc ENGINE:-
 L/ALLOY H.R.G. CYLINDER HEAD
 TWIN 40 DCOE WEBER CARBURETTORS
 10.3/1 COMPRESSION RATIO
 MECHANICALLY AND VOLUMETRICALLY BALANCED
 ABARTH EXHAUST SYSTEM
 COOL AIR INTAKE
 NO FAN BLADES FITTED
 SPORTS COIL
 CONTROLLED OIL TEMPERATURE

As this crankshaft is considered to be unsafe above 6,500rpm., I decided to leave the valve gear heavy and deliberately allow valve float at about 6,000-6,200rpm. and so protecting the engine from serious damage. As I have not any engine test facilities peak tuning was not possible and the actual power output was unknown, however using the test bed figures of an MGB engine (of similar tune), I managed to derive an approximate power curve as can be seen on Fig. 11. If you wish to know the effects of these modifications, be sure to read the next and final chapter in which I will attempt to describe the performance of the car as an everyday form of transport.
